HVAC Drain Issues: Cost and Health Issues

Condensate drainage requires more than a properly designed trap and an adequate maintenance plan

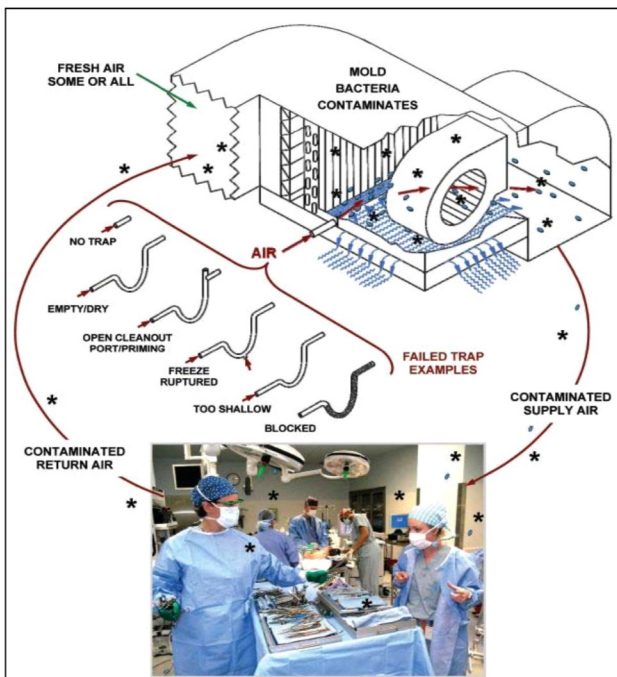
FIGURE 1: The consequences of trap failures as defined by ASHRAE.

By default, a drain system with a condensate trap has become the industry standard. The technical and rational basis for its acceptance and endorsement by the HVAC industry is not known. The trap, a key part of this system, exhibits so many failure modes that reliable condensate drainage varies from unlikely to impossible. The numerous trap failure modes, as reported by ASHRAE, are summarized in the sidebar. How these various failures cause damage and threaten health are illustrated in Figure 1.

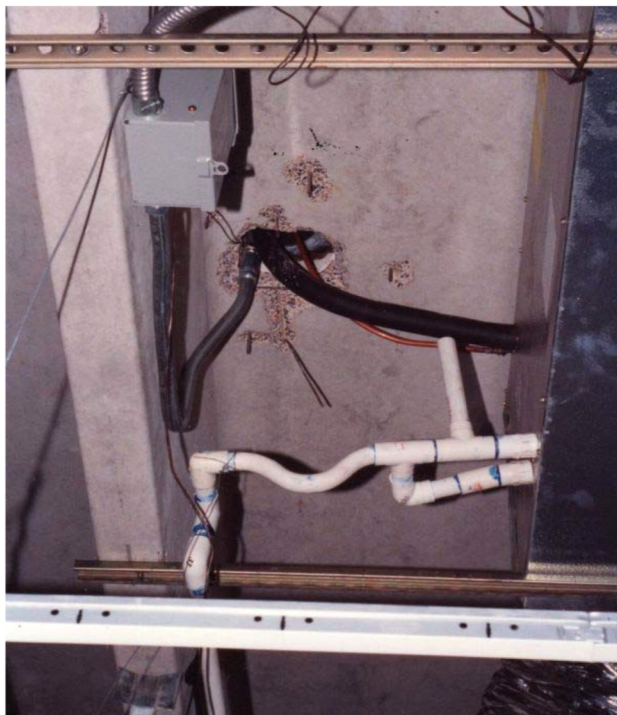
FIGURE 2: A typical industry-standard trapped system.

Many visits to air conditioned facilities in the U.S. show that failed industry-standard drain systems are causing enormous property damage and creating potentially health-threatening conditions. The photographs in Figures 2, 3, 4, and 5 show failed traps and depict examples of the common and widespread damage and contamination they cause.

Clearly, the widely used industry-standard condensate drain system does not meet the plumbing codes. That observation coupled with the typical failures and consequences illustrated in Figures 2, 3, 4, and 5 show that trapped drain systems are unsuitable for HVAC systems. The photographs show only damage and possible contamination. But, the impact of these conditions on the health of building occupants can be fully appreciated only when it's realized that all air in a conditioned space passes through the contaminated air handler several times per hour. It also indicates why increased outside ventilating air, which passes through the contaminated air handler, may be less effective than desired or expected.

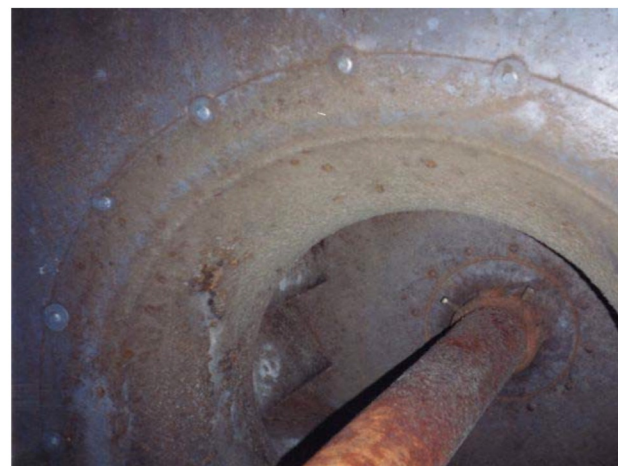
FIGURE 3: A damaged and contaminated air handler.

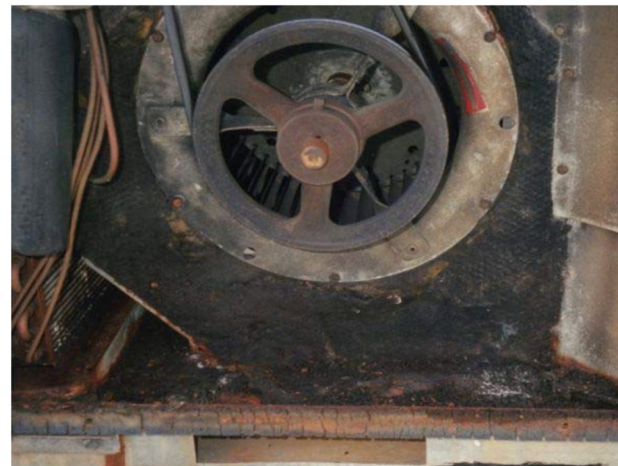
FIGURE 4: While this illustration only shows a flawed air handler, the impact on the health of building occupants can be fully appreciated only when it's realized that all air in a conditioned space passes through the contaminated air handler several times per hour.

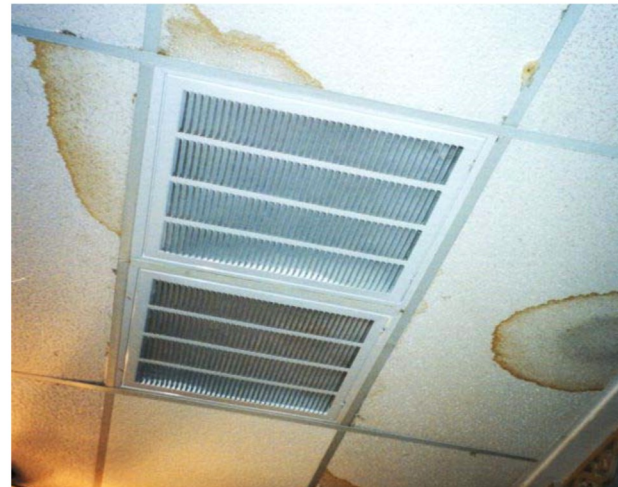
FIGURE 5: A damaged and contaminated ceiling.
