*Improved  
Restaurant  
HVAC Systems*

- **Decreased Maintenance,**
- **Lower Life Cycle Costs,**
- **Better "IAQ" Indoor Air Quality**

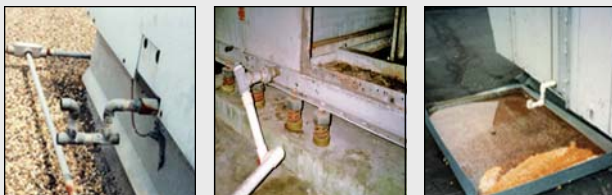
**Figure 1.** Typical trapped systems that meet industry codes

Despite the numerous failure modes common to the condensate trap, it is an integral part of the drain system now accepted as the “industry standard.” The success of this system depends upon the best possible trap design and effective maintenance by the building operator. But, there is no standard or useful guidance for performing either of these functions. The widely applicable national, and many local, plumbing codes state only that HVAC drain systems shall be trapped, leaving detail design to others. Drain systems like those shown in **Figure 1** are the results. Each of these systems meets applicable codes; that is, they are trapped. Successful maintenance is impossible, since none can effect successful condensate drainage.
