*Improved
Hospital
HVAC Systems*

CostGard™
Condensate Drain Systems

A solution developed by Trent Technologies, a privately held engineering research and development company.

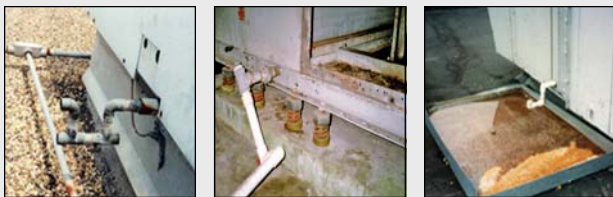
Figure 1. Typical trapped systems that meet industry codes

Despite the numerous failure modes common to the condensate trap, it is an integral part of the drain system now accepted as the “industry standard.” The success of this system depends upon the best possible trap design and effective maintenance by the building operator. But, there is no standard or useful guidance for performing either of these functions. The widely applicable national, and many local, plumbing codes state only that HVAC drain systems shall be trapped, leaving detail design to others. Drain systems like those shown in **Figure 1** are the results. Each of these systems meets applicable codes; that is, they are trapped. Successful maintenance is impossible, since none can effect successful condensate drainage.

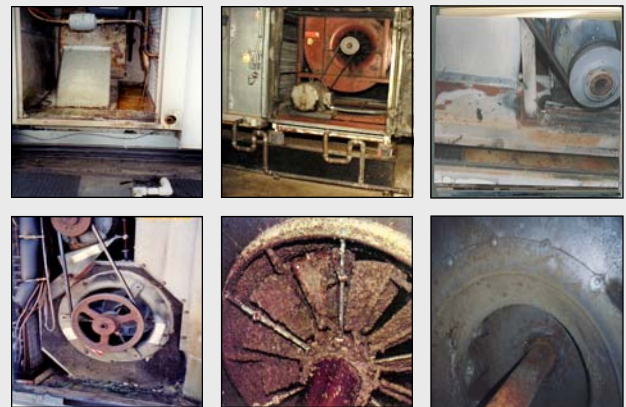
Figure 2. Damaged and health threatening air handlers caused by failed drain systems

Most HVAC units in this country are equipped with the “industry standard” drain systems. The frequent and untimely failures of these systems impose costly burdens on building owners in terms of health threats, property damage, service calls, maintenance effort, equipment life, and life cycle cost. The photographs in **Figures 2** and **3** illustrate the property damage caused by the failure of “industry standard” drain systems. The impact of these failures on health is appreciated only when it is realized that all air in the conditioned space passes through the contaminated air handlers several times per hour.

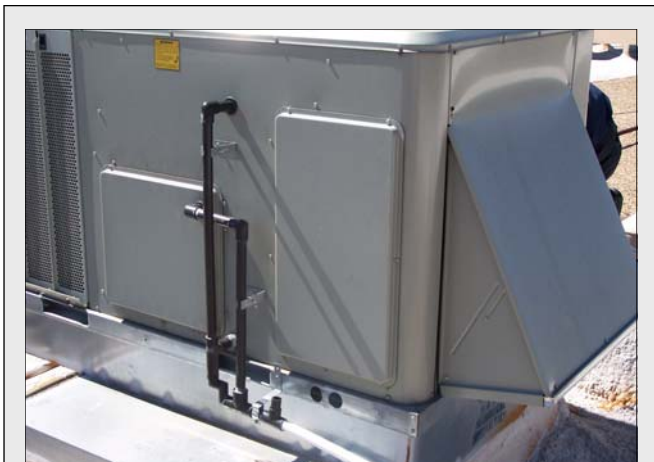
Figure 4. Typical installation of a CostGard™ Condensate Drain System

In keeping with the savings it provides building owners, the system has been named: CostGard™ Condensate Drain System. A typical installation on a rooftop unit is shown in **Figure 4**.
