*Improved  
Retail Store  
HVAC Systems*

- **Decreased Maintenance,**
- **Lower Life Cycle Costs,**
- **Better "IAQ" Indoor Air Quality**

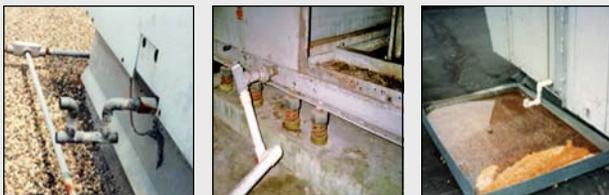
**Figure 1.** Typical trapped systems that meet industry codes

Despite the numerous failure modes common to the condensate trap, it is an integral part of the drain system now accepted as the “industry standard.” The success of this system depends upon the best possible trap design and effective maintenance by the building operator. But, there is no standard or useful guidance for performing either of these functions. The widely applicable national, and many local, plumbing codes state only that HVAC drain systems shall be trapped, leaving detail design to others. Drain systems like those shown in **Figure 1** are the results. Each of these systems meets applicable codes; that is, they are trapped. Successful maintenance is impossible, since none can effect successful condensate drainage.

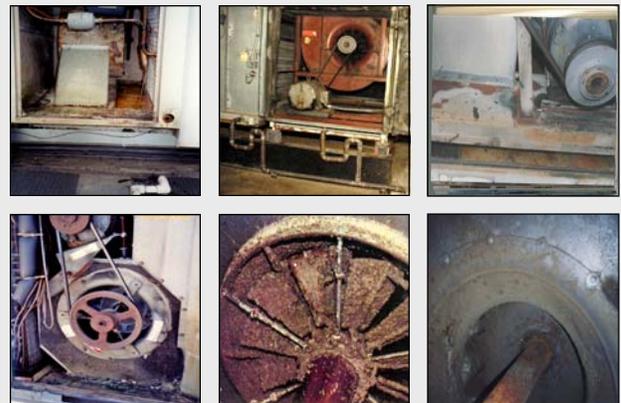
**Figure 2.** Damaged and health threatening air handlers caused by failed drain systems

Most HVAC units in this country are equipped with the “industry standard” drain systems. The frequent and untimely failures of these systems impose costly burdens on building owners in terms of health threats, property damage, service calls, maintenance effort, equipment life, and life cycle cost. The photographs in **Figures 2** and **3** illustrate the property damage caused by the failure of “industry standard” drain systems. The impact of these failures on health is appreciated only when it is realized that all air in the conditioned space passes through the contaminated air handlers several times per hour.

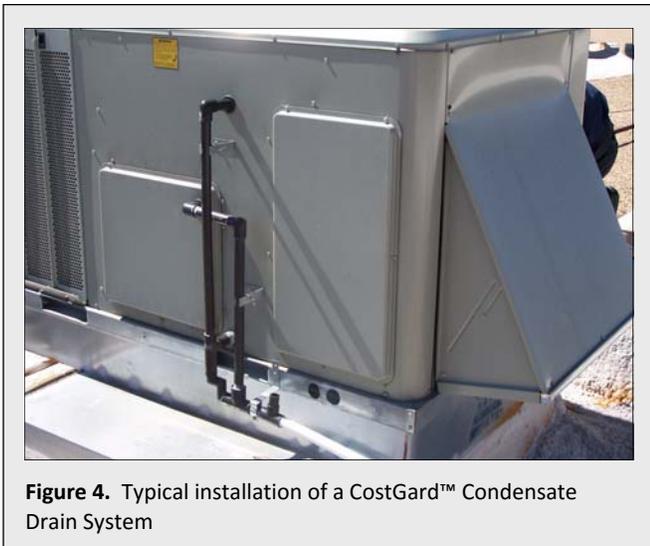
**Figure 4.** Typical installation of a CostGard™ Condensate Drain System

In keeping with the savings it provides building owners, the system has been named: CostGard™ Condensate Drain System. A typical installation on a rooftop unit is shown in **Figure 4**.
