*Improved  
School  
HVAC Systems*

- **Decreased Maintenance,**
- **Lower Life Cycle Costs,**
- **Better "IAQ" Indoor Air Quality**

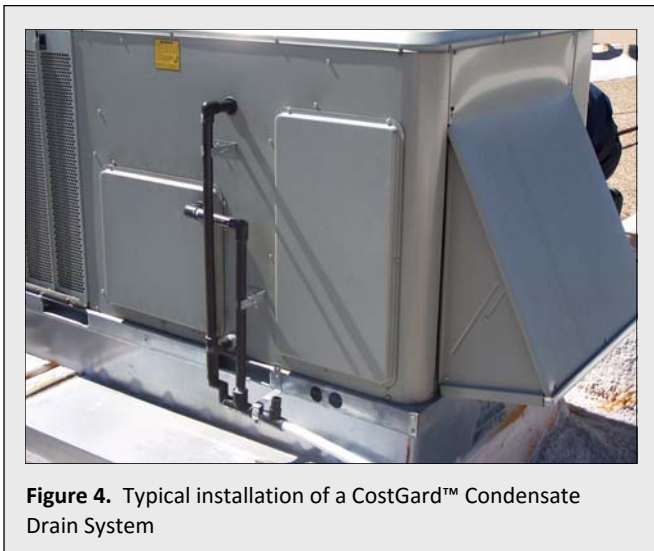
**Figure 4.** Typical installation of a CostGard™ Condensate Drain System

In keeping with the savings it provides building owners, the system has been named: CostGard™ Condensate Drain System. A typical installation on a rooftop unit is shown in **Figure 4**.
